Precautions when installing the product in NB6C/NB8C

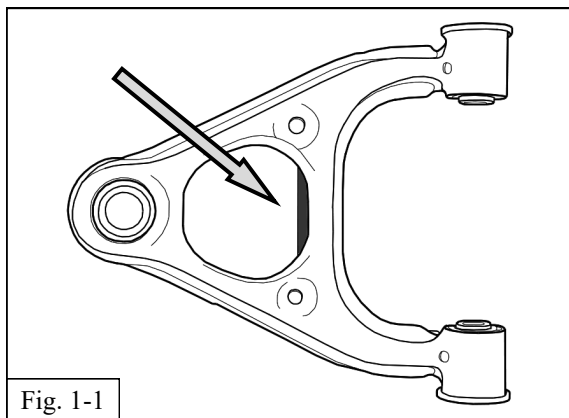
*Note: A clearance between the upper control arm and the suspension may be close depending on the upper control arm shape when installing the product in NB6C/NB8C.

Concerned upper control arm shape is as seen in Fig. 1.

Specifically, the black shaded section (reinforced part of the arm) may interfere with the suspension.

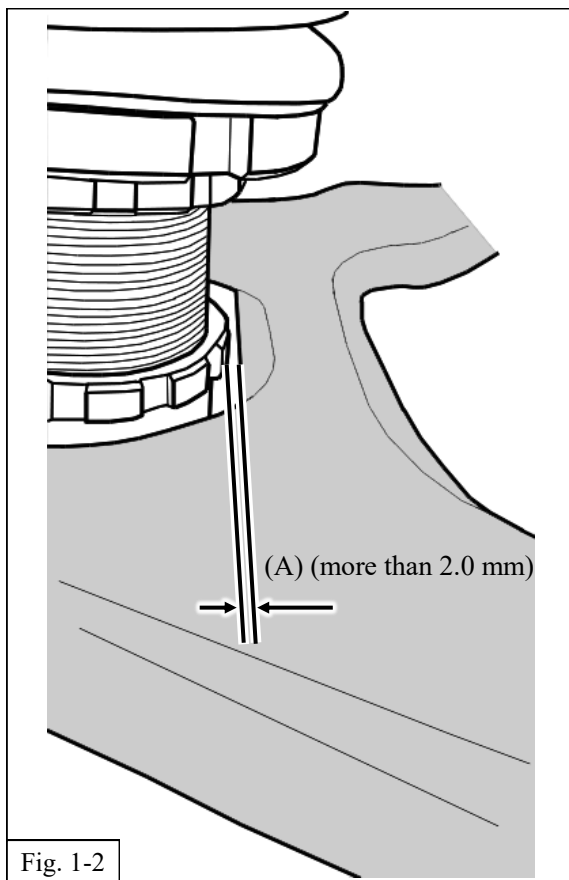
(Fig. 1-2)

Check the clearance (A) of between the upper control arm and the suspension should be more than 2.0 mm at a 0 gravity state (Vehicle was jacked up) when installing the product.

Adjust the camber angle to keep the clearance (A) becomes more than 2.0 mm if the clearance is less than 2.0 mm.
